**PRELIMINARY ASSESSMENT/  
VISUAL SITE INSPECTION**

**SANCAP ABRASIVES, INC.  
ALLIANCE, OHIO  
OHD 093 289 700**

**FINAL REPORT**

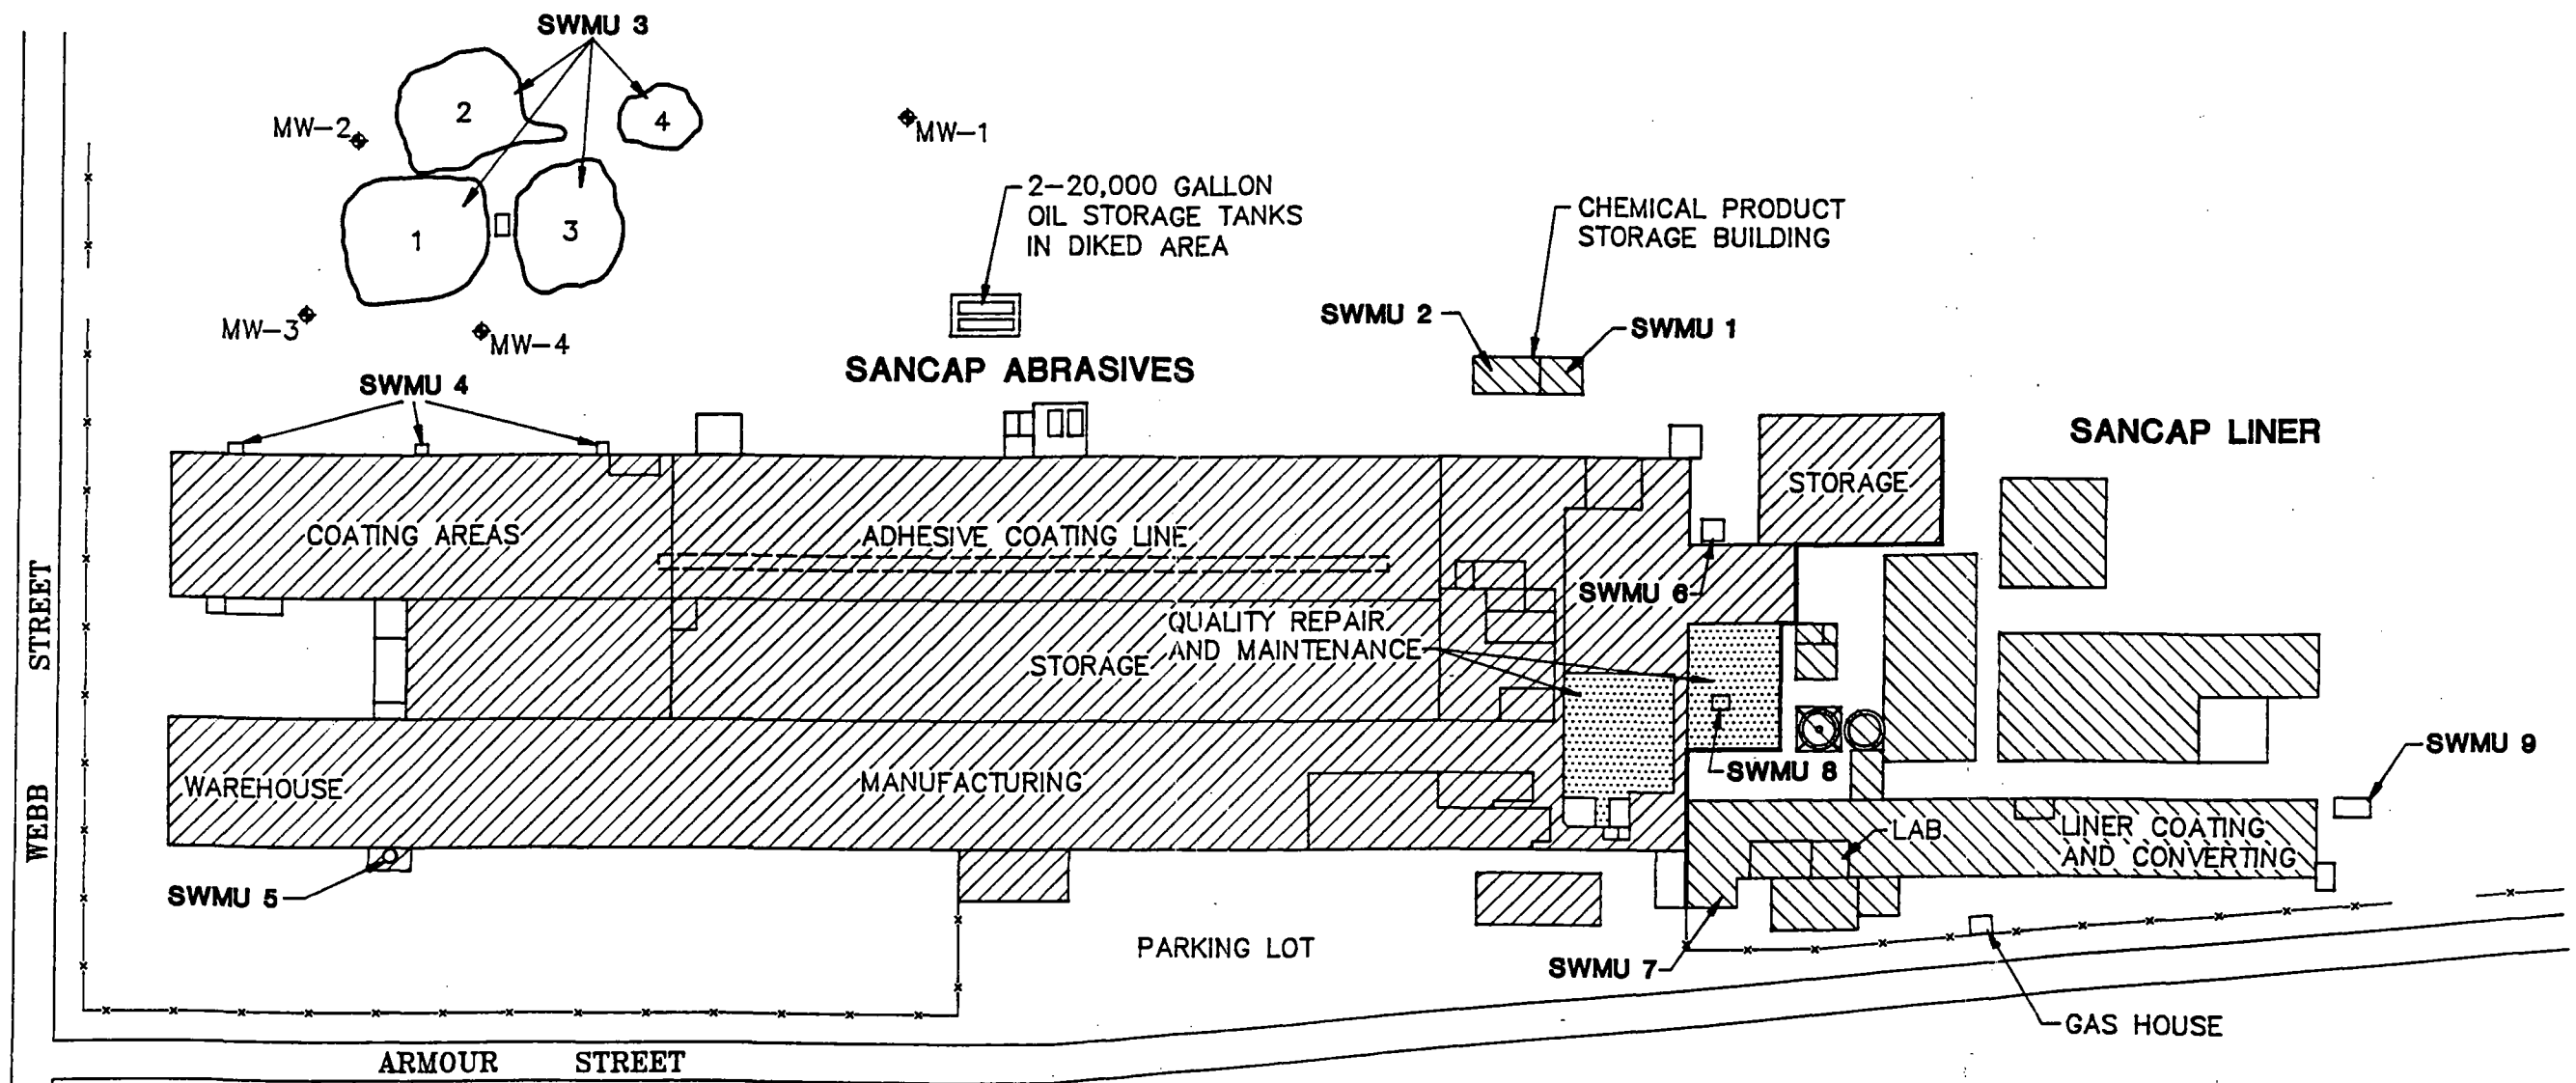
**SOLID WASTE MANAGEMENT UNITS**

- SWMU 1** - FORMER REGULATED HAZARDOUS WASTE STORAGE AREA
- SWMU 2** - CURRENT HAZARDOUS WASTE ACCUMULATION AREA
- SWMU 3** - SETTLING LAGOONS
- SWMU 4** - WASTEWATER SUMPS
- SWMU 5** - WASTEWATER PRETREATMENT UNIT
- SWMU 6** - ABRASIVE ROLL-OFF BOX
- SWMU 7** - STILL
- SWMU 8** - USED OIL STORAGE DRUM
- SWMU 9** - LINER ROLL-OFF BOX

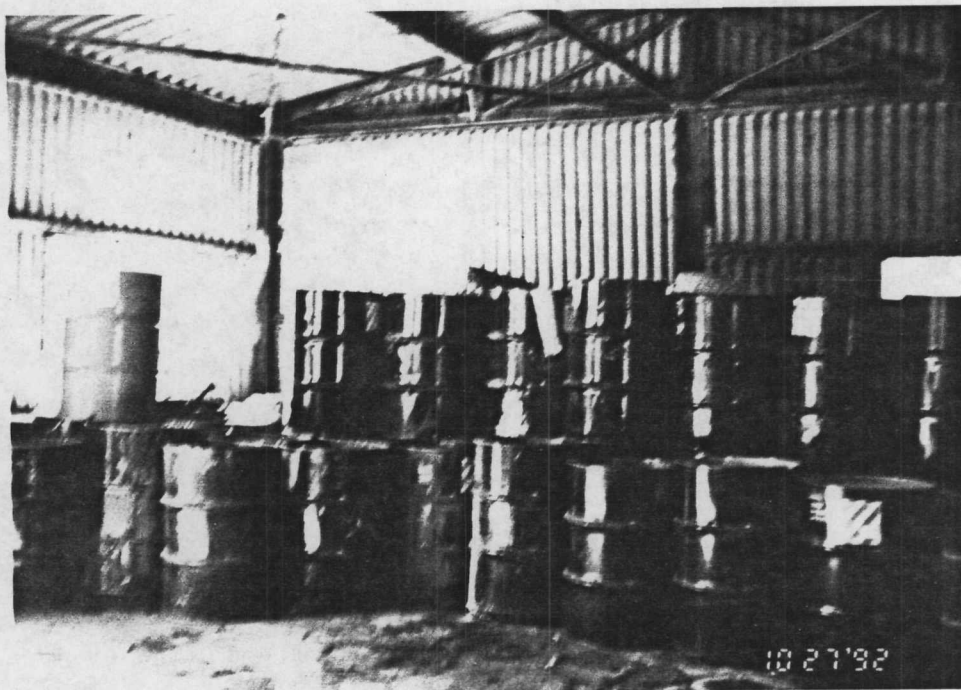
Photograph No. 1

PRC observed approximately 120 drums of hardened resin stored in the area in open 55-gallon steel drums. According to facility representatives, this hardened resin had been left by SIA before the facility was sold to Robert Stuhlmiller in 1992. PRC did not note any signs of spills, leaks or solvent odor at the time of the VSI.

Description: Former Regulated Hazardous Waste Storage Area; this shows about 120 55-gallon drums of waste hardened resin left by SIA

PRC recommends the facility arrange for proper disposal of the drums containing hardened resin on site.

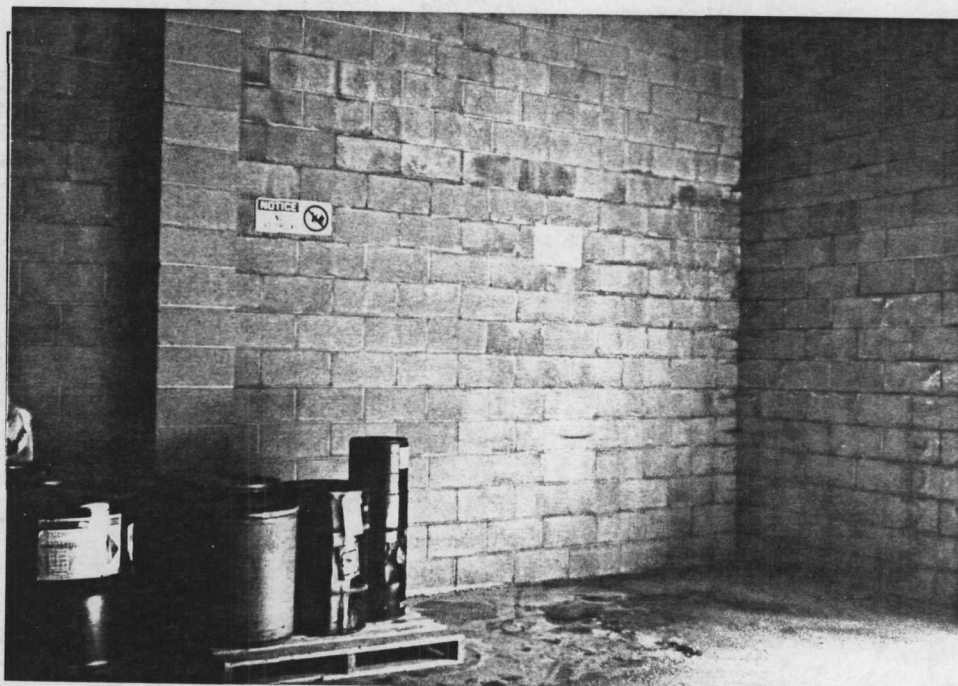
Photograph No. 2

PRC observed no hazardous waste being accumulated at the unit at the time of the VSI. PRC observed oil-type stains throughout the building and in the waste storage area. Numerous product drums were stored throughout the building.

product drums used by both Sancap Abrasives and Sancap Liner. PRC observed oil-type stains throughout the building. The room has a powered ventilation system to prevent the buildup of flammable vapors. The potential for release to ground water, surface water, air, and on-site soils is low.

Description: Current Hazardous Waste Accumulation Area; no hazardous waste on site; note oil-type stains from product storage which takes place in this building

Recommendations: PRC recommends no further action for this unit.

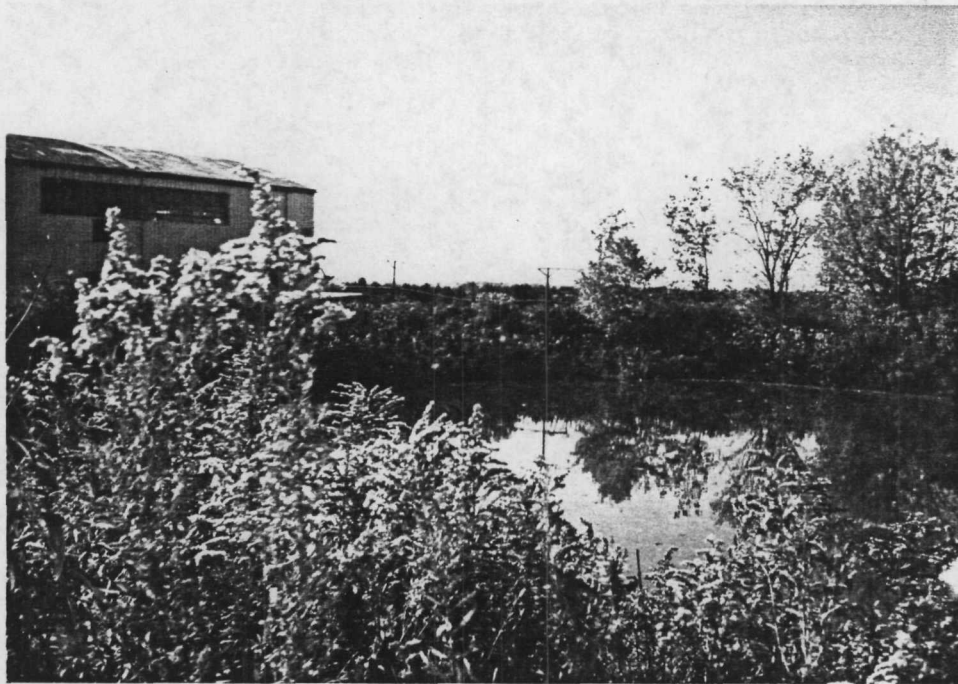
Observations:	PRC observed water in the lagoons at the time of the VSI. According to facility representatives, this water consisted of rainwater and the high ground water in the area. PRC observed that there were no active pumping operations at the time of the VSI. The former pumphouse and associated piping were rusted and in disrepair.

Photograph No. 3  
 Orientation: East  
 Description: Settling Lagoon; receiving lagoon (Lagoon 1)

Recommendations: PRC recommends the facility continue with closure proceedings under the OEPA guidance.

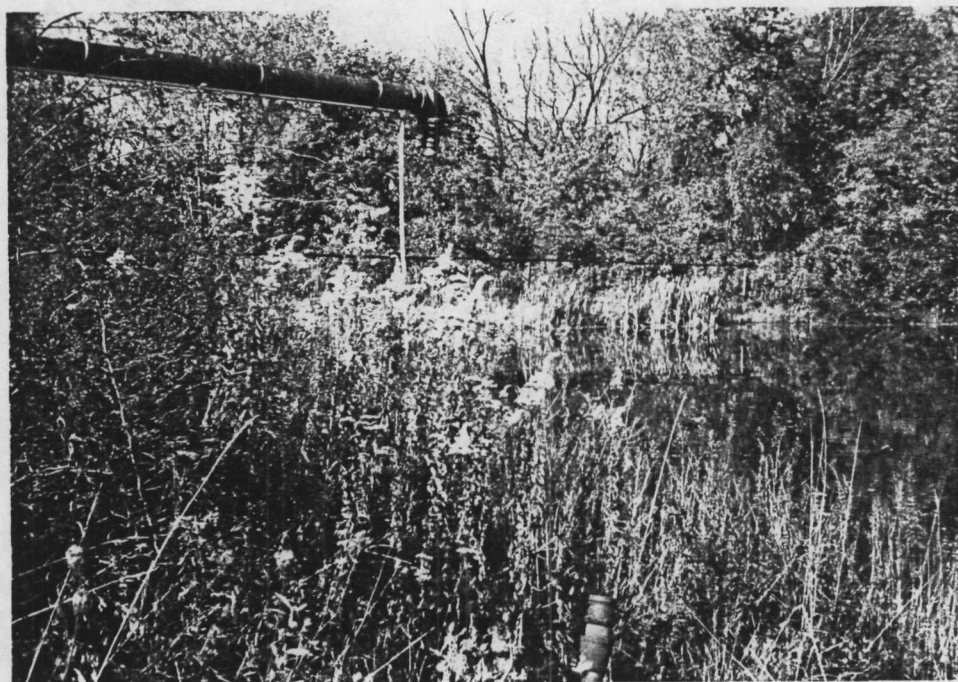
Photograph No. 4  
 Orientation: Northwest  
 Description: Settling Lagoon; discharge lagoon (Lagoon 2)

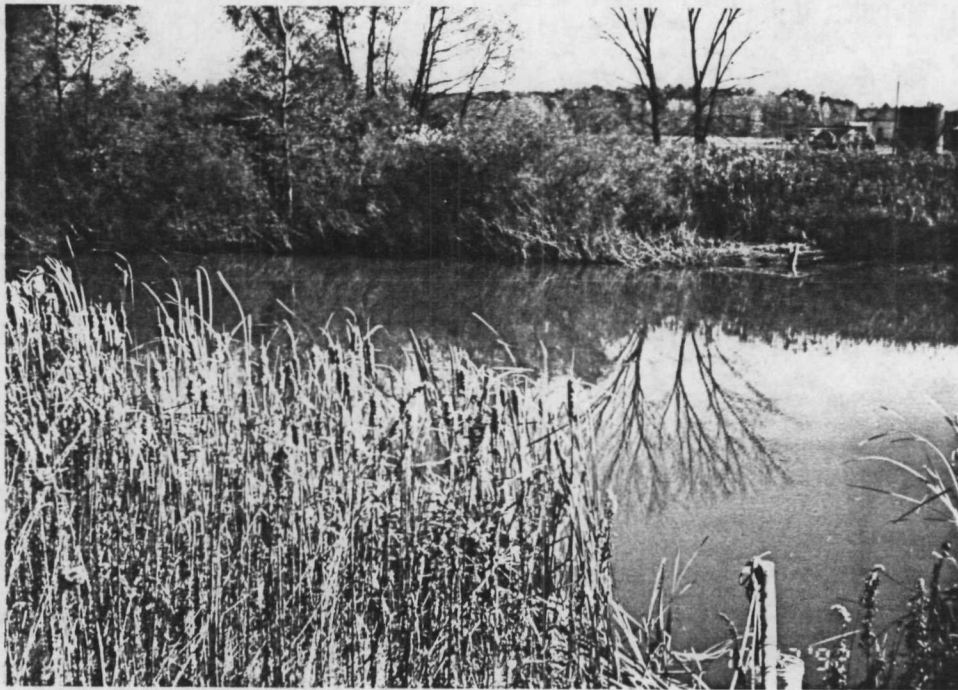
Photograph No. 5  
 Orientation: Southwest  
 Description: Settling Lagoon; rain water collection lagoon (Lagoon 3)

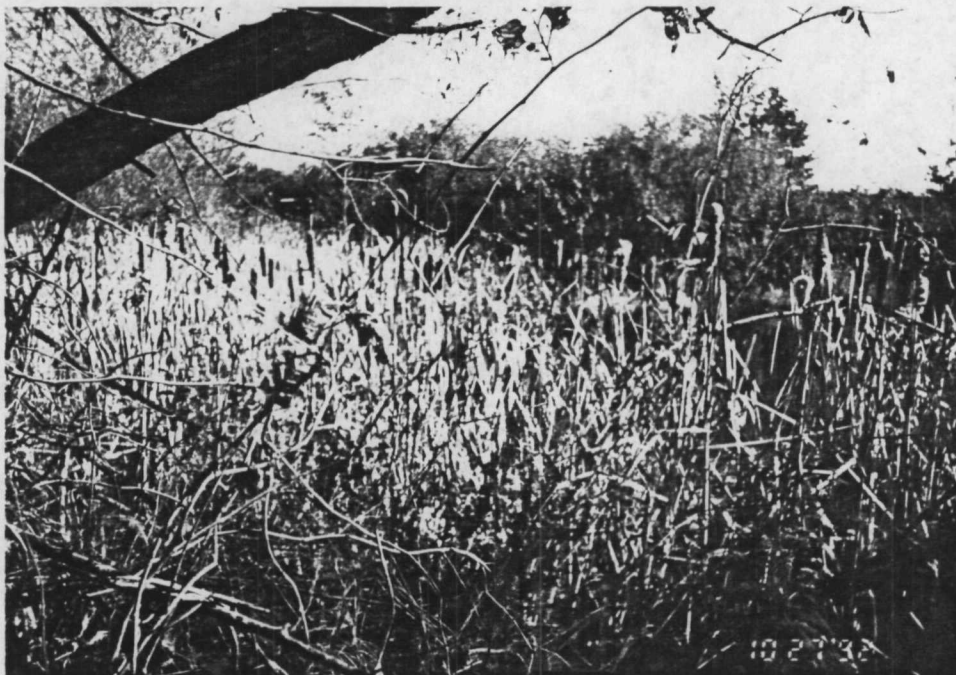
Photograph No. 6  
 Orientation: East  
 Description: Settling Lagoon; this lagoon was a source of soil for berm construction and was occasionally used for dilution water (Lagoon 4)

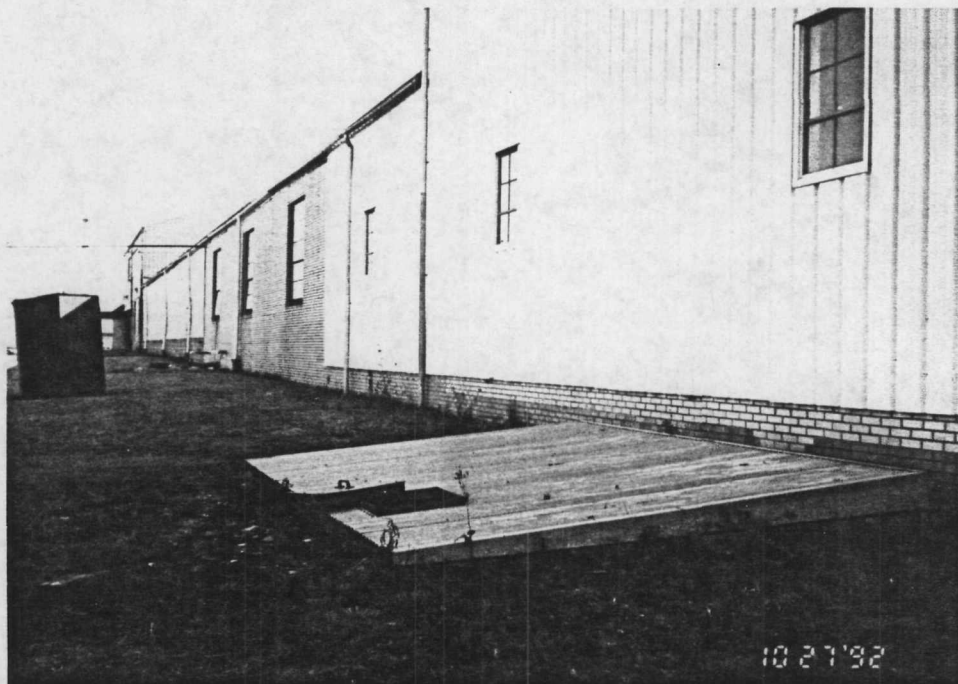
Photograph No. 7  
 Orientation: Southeast  
 Description: Wastewater Sumps; west sump

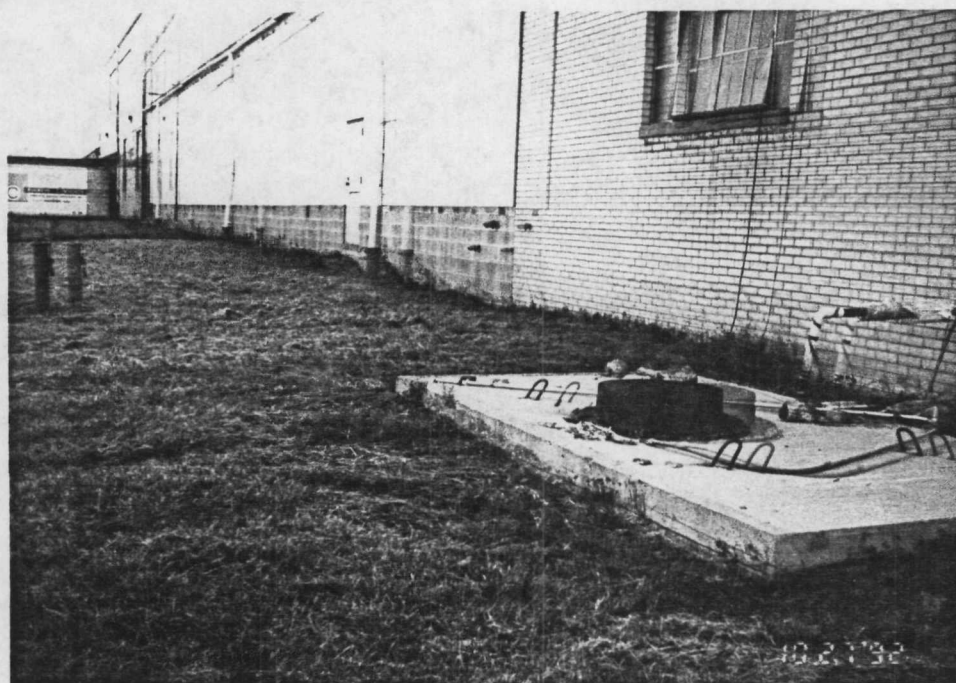
Photograph No. 8  
 Orientation: East  
 Description: Wastewater Sumps; center sump

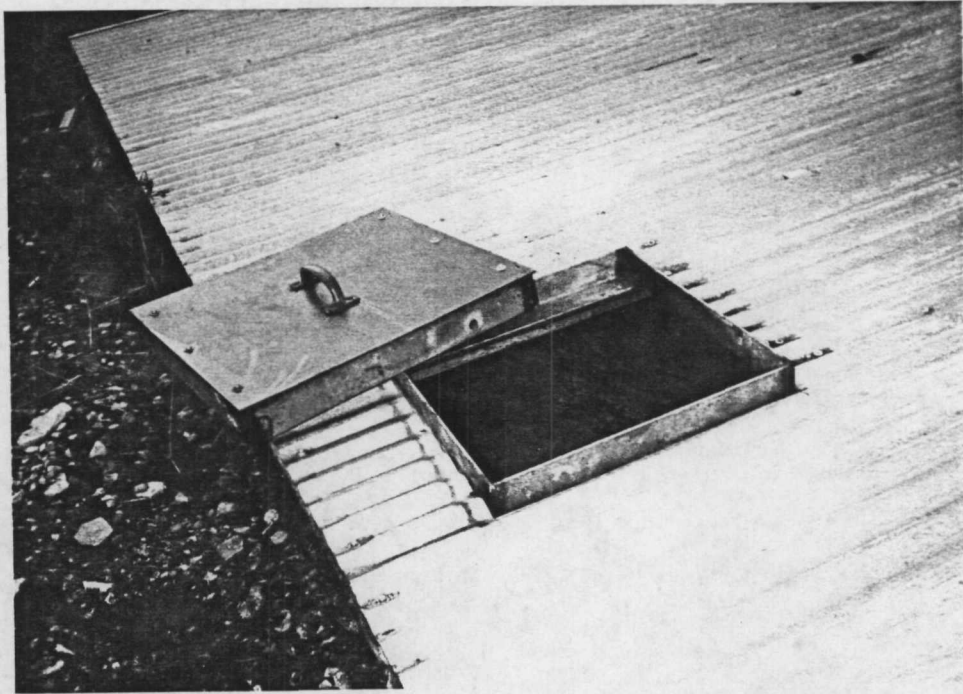
PRC observed soapy water in the wastewater sump during the VSI. PRC did not note any solvent odors near this unit. PRC did not note any indications of release at this unit.

Photograph No. 9  
 Orientation: West  
 Description: Wastewater Sumps; wastewater in west sump

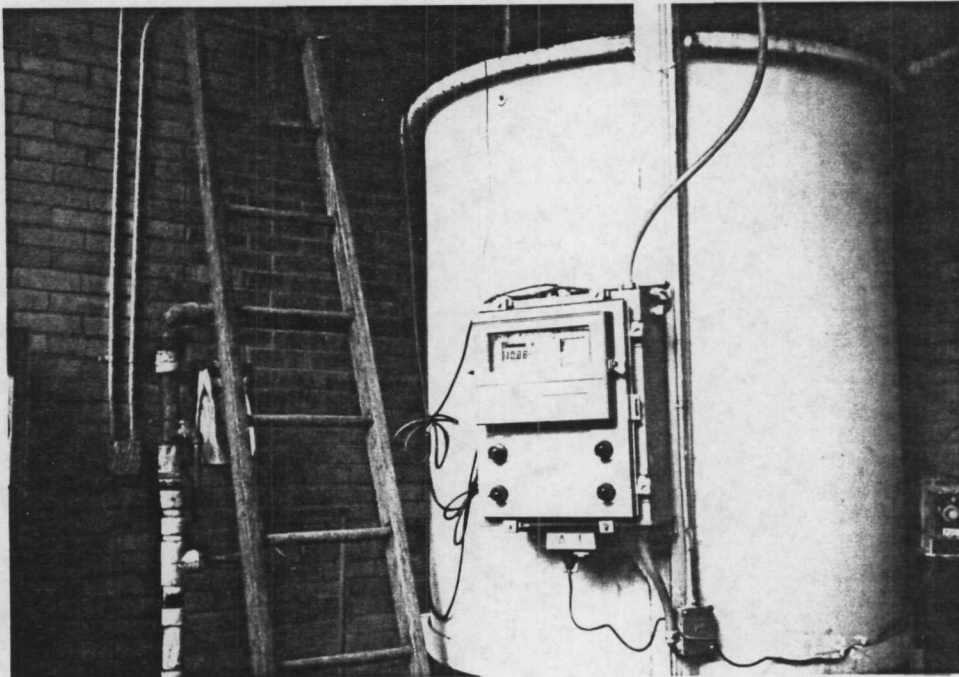
Conclusions: This unit consists of a 1,500-gallon aboveground fiberglass tank that is located indoors above a concrete floor. Wastewater from the center sump (SWMU 4) is pumped to the unit where the pH adjustment, if necessary, to meet the facility's discharge limit of 6 to 10. The Sancap Abrasive facility discharges wastewater from the Wastewater Pretreatment Unit (SWMU 5) under City of Alliance Permit Number 216-A. The tank is located aboveground, so leaks from the tanks would be detected. The tank is located in a dedicated concrete room with a concrete floor to manage potential leaks. The potential for release to ground water, surface water, air, and on-site soils is low for this unit.

Photograph No. 10  
 Orientation: Northwest  
 Description: Wastewater Pretreatment Unit; fiberglass tank above a concrete floor

Recommendations: PRC recommends no further action for this unit.

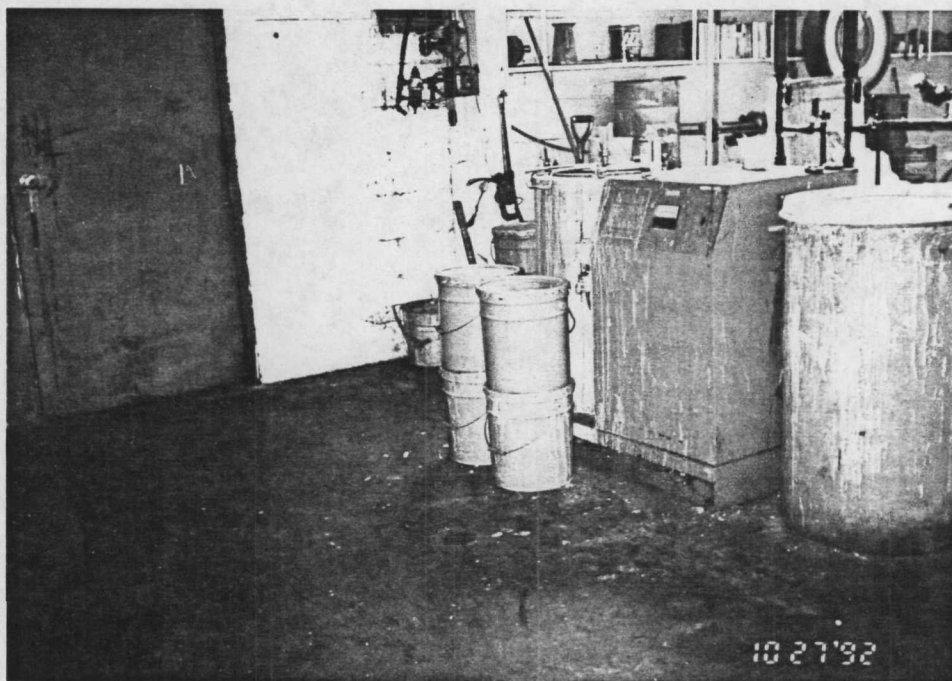
Photograph No. 12

PRC did not observe any signs of spills or leakage at this unit.  
PRC did not observe methylene chloride still bottoms (F002) in the unit at the time of the VSI.

PRC recommends the facility manage and accumulate the waste methylene chloride still bottoms (F002) from this unit as a hazardous waste.

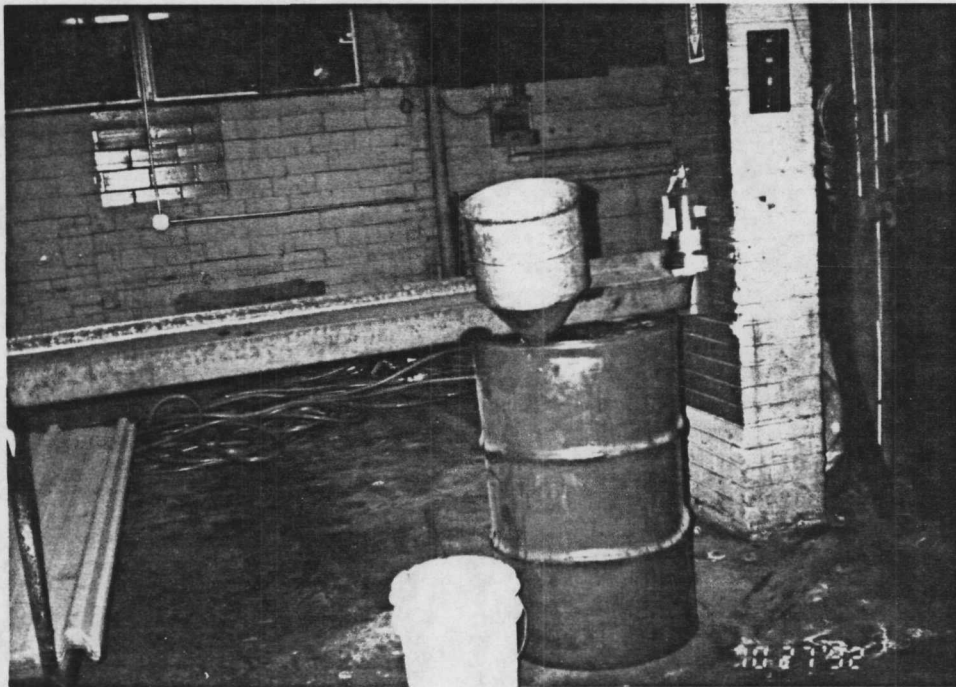
Photograph No. 13  
 Orientation: North  
 Description: Used Oil Storage Drum; 55-gallon drum on a concrete floor

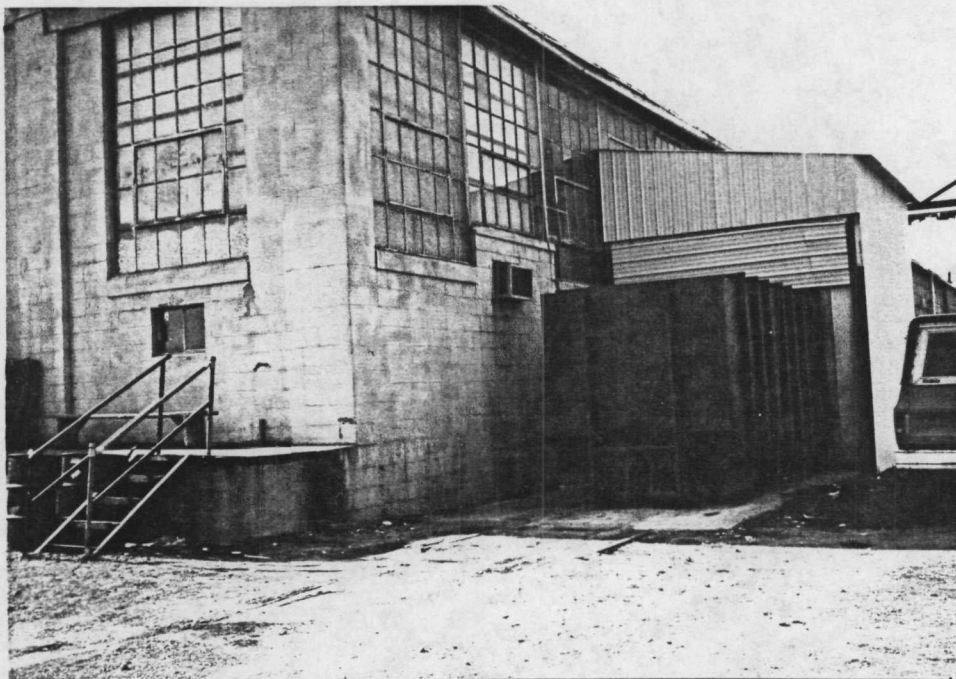
Photograph No. 14  
 Orientation: West  
 Description: Liner Roll-Off Box; covered box on a concrete pad

Recommendations: The facility should manage and dispose of the methylene chloride still bottoms (F002) as a hazardous waste.
